## SE TX Aerial Lift/Scissor Lift/Boom Truck (AL/SL/BT) Overview\* (02/2021)

Aerial lifts and scissor lifts are commonly referred to as Mobile Elevating Work Platforms (MEWPs) while boom trucks are a separate category. For purposes of this flyer all three types of equipment were combined together since they are used in a similar manner – lifting an employee to work at elevation.

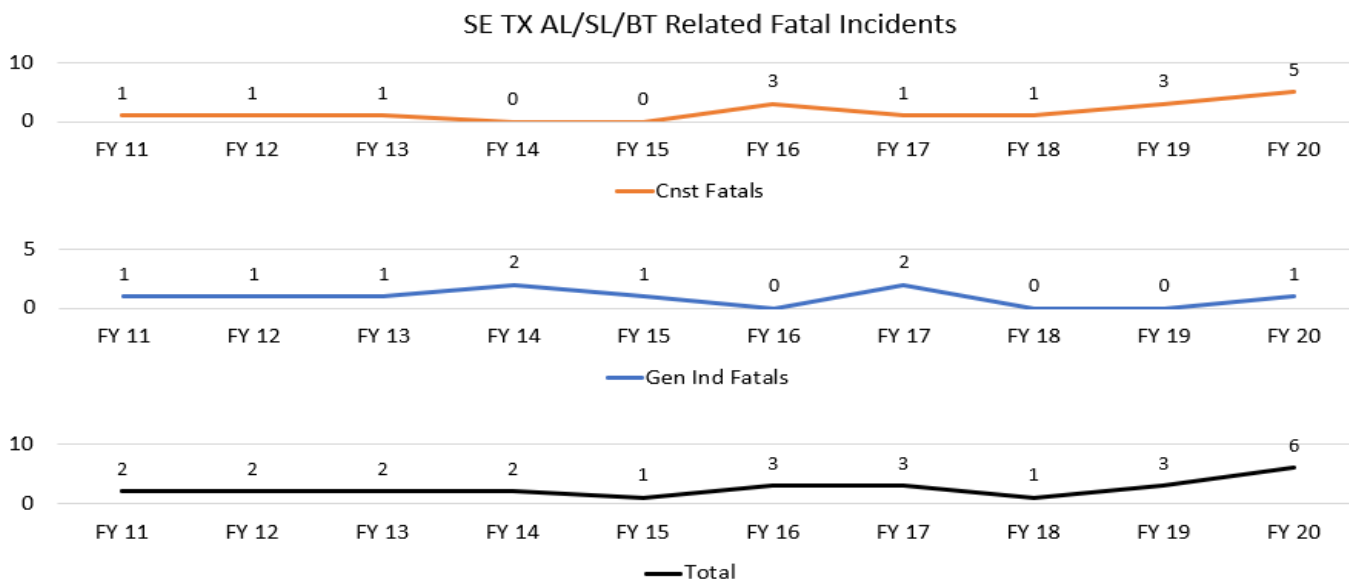
### AL/SL/BT Related Fatality Incidents by Fiscal Year (FY) SE Texas

FY 11	FY 12	FY 13	FY 14	FY 15	FY 16	FY 17	FY 18	FY 19	FY 20	Total
2	2	2	2	1	3	3	1	3	6	25

When looking at fatal incidents overall, the time period of FY 11 – FY 15, falls were most prevalent event, particularly in general industry. Other events such as electrical, struck by, or caught between were intermittent but more represented in construction. When looking at the time period of FY 16 – FY 20, fall related events occurred, but in overall events, electrical related incidents seemed to have significantly increase, particularly in construction.

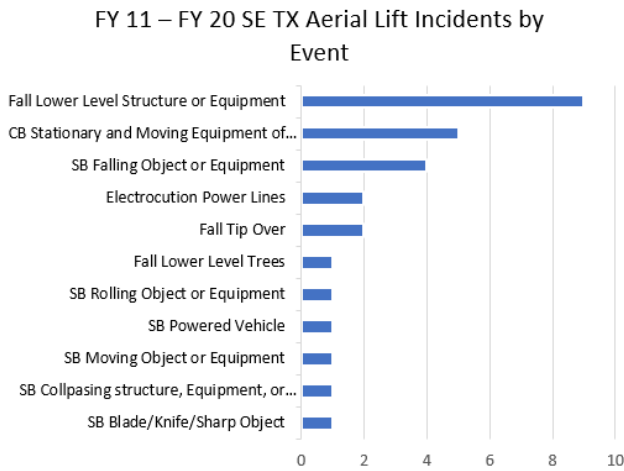
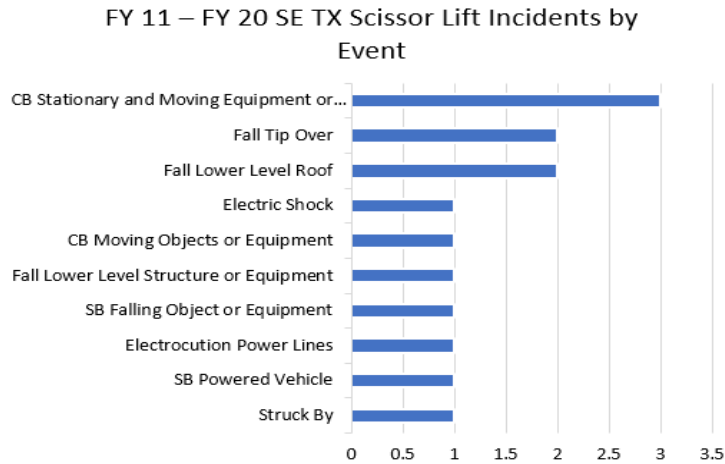
## All SE TX Incidents on Record (25 fatalities and 26 Serious) by Major Type of Equipment

When looking at the fatalities and serious incidents, failure to follow a few key safety practices seem to be the cause of the majority of incidents. Workers must be trained on how to safely operate the equipment and to identify and avoid hazards. Many of the incidents in SE TX appear to relate to these safety hazards:
